Detection of Multiple Cracks in Four-Point Bending Tests Using the Coda Wave Interferometry Method

Xin Wang ^{1,*}, Joyraj Chakraborty ²

Abstract: The enlargement of the cracks outside the permitted dimension is one of the main causes for the reduction of service life of Reinforced Concrete (RC) structures. Cracks can develop due to many causes such as dynamic or static load. When tensile stress exceeds the tensile strength of RC, cracks appear. Traditional techniques have limitations in early stage damage detection and localisation, especially on large-scale structures. The ultrasonic Coda Wave Interferometry (CWI) method using diffuse waves is one of the most promising methods to detect subtle changes in heterogeneous materials, such as concrete. In this paper, the assessment of the CWI method applied for multiple cracks opening detection on two specimens based on four-point bending test is presented. Both beams were monitored using a limited number of embedded Ultrasonic (US) transducers as well as other transducers and techniques (e.g., Digital Image Correlation (DIC), LVDT sensors, strain gauges, and Fiber Optics Sensor (FOS)). Results show that strain change and crack forma

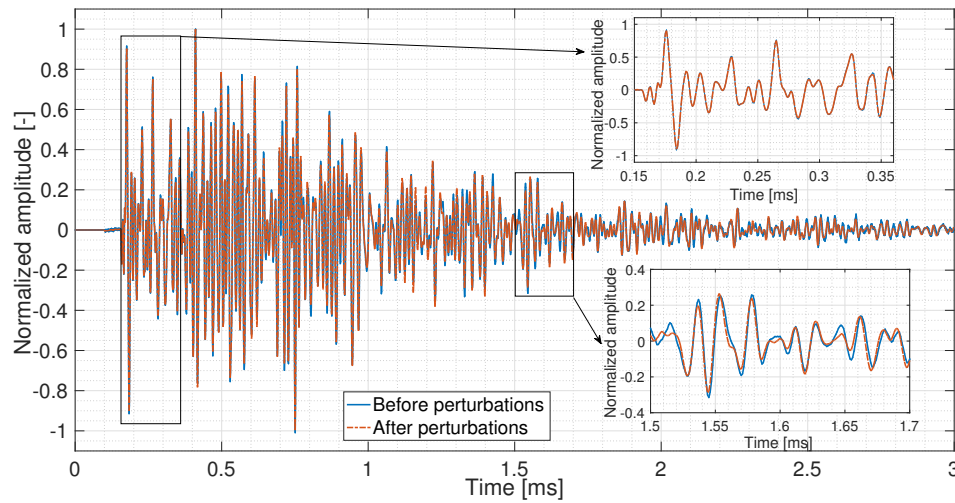
Figure 1. Signals recorded before and after small perturbations in the medium.

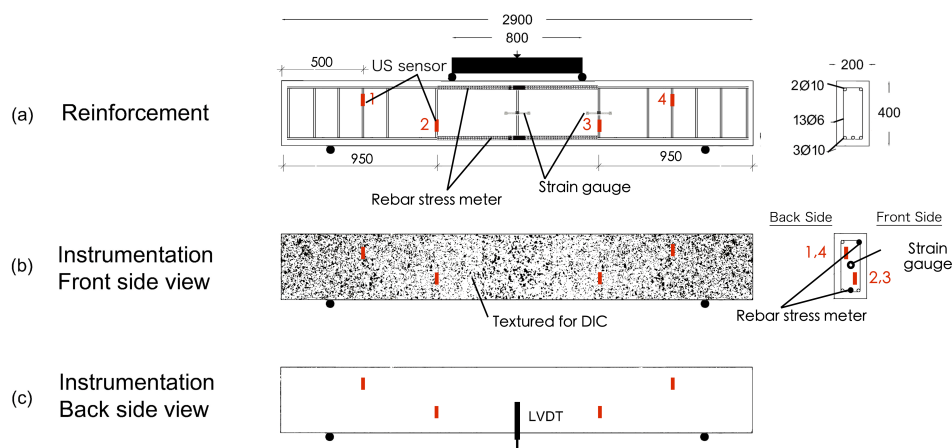
**Figure 7.** Dimensions of the beam, rebars distribution, and sensors positions at NEOSTRAIN.

A limited number of US transducers was attached on the stirrups and installed inside both beams before casting. Two vibrating wire strain gauges and two rebar stress meters were installed in the beam at NEOSTRAIN to measure the strain variation in the beam and the rebar. As the quantity and position of all the cracks were not predictable, only four LVDT sensors were glued on the back surface of the beam at BAM to measure the Crack Opening Displacement (COD) for a few cracks on the surface and to double verify the FOS measurement. Strain changes and crack width inside the beam were also measured by FOS. Although FOS technique was not applied at NEOSTRAIN, DIC technique which covered the whole beam still provided a roughly COD and propagation map. Position and spacing between all the transducers are shown in Figures 6 and 7.

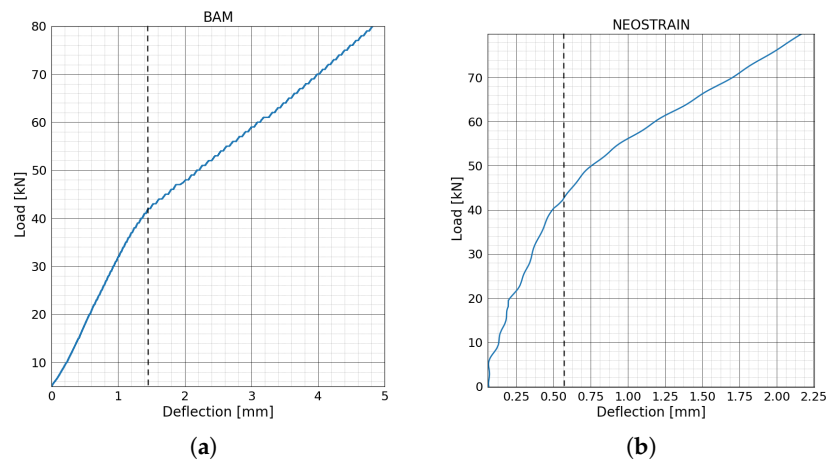
Figure 10. Load-deflection curve for bending test at (a) BAM and at (b) NEOSTRIN.

The deflections of two beams during the four-point bending test are shown in Figure 10. Load-deflection curves for both beams lost their linearity at around 42 kN; the beams went into the plastic phase from the elastic phase, meaning that single or multiple cracks appeared. As mentioned

in the previous section, the loading procedure at NEOSTRIN was controlled manually; there was a small load fluctuation during the whole test.

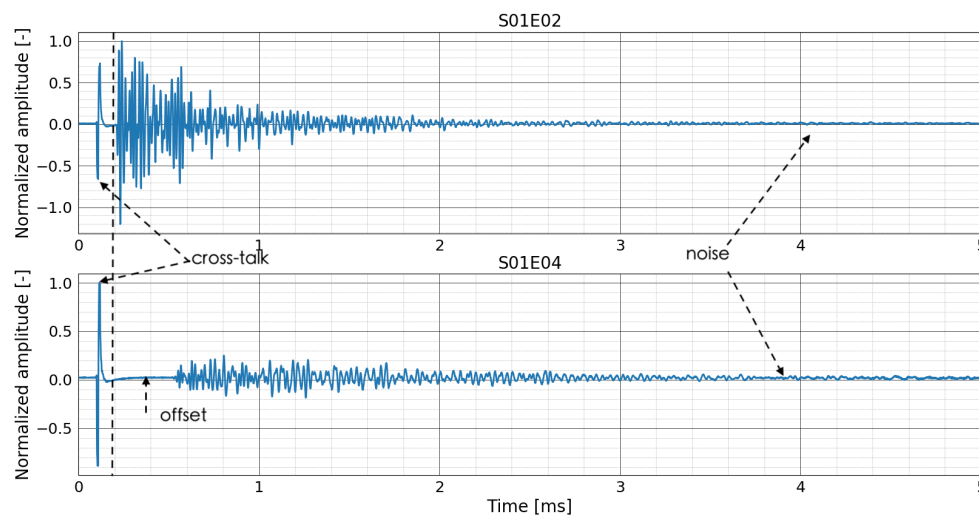
Figure 14. Correlation coefficient and relative velocity change of all the transducers combinations in test at BAM.

As an example, signals measured by transducer combinations S01E02 and S01E04 ($S_{xx}E_{yy}$: transmitter xx and receiver yy during the initial stage of the beam at NEOSTRIN are plotted in Figure 14. The signals need to be pre-processed to filter the noise and to remove offset and cross-talk (more details can be found in [32]). As the distance between transducer number 1 and 4 is longer than that of transducer number 1 and 2, the signal received by transducer combination S01E04 has a longer time of flight and lower amplitude due to the attenuation of US wave in concrete.

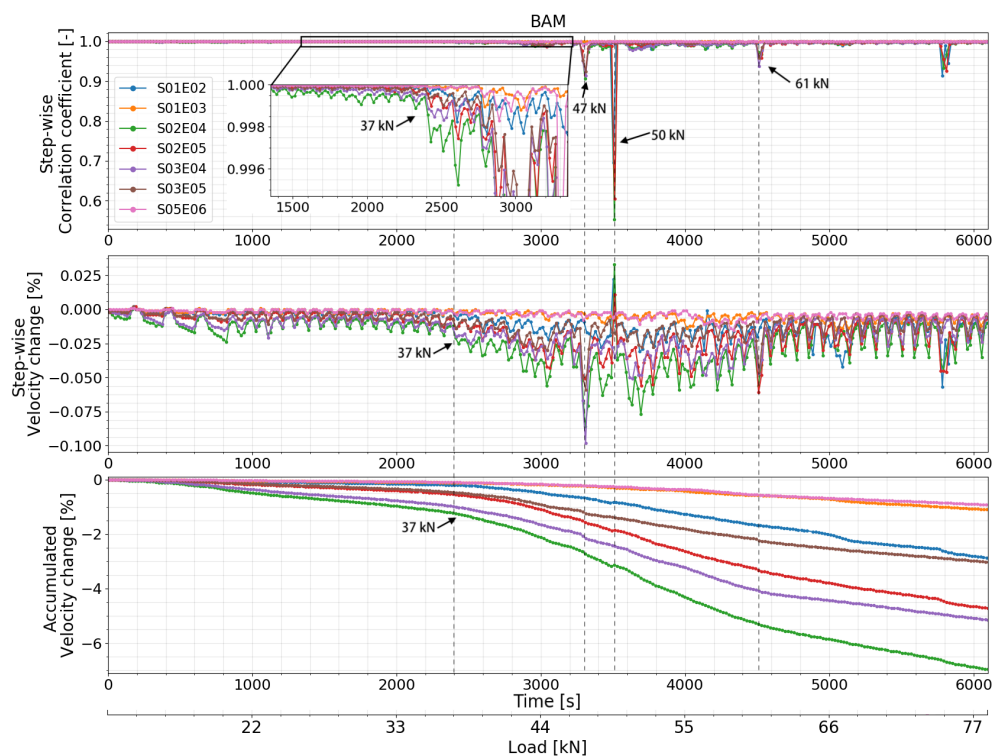
Figure 17. Correlation coefficient and relative velocity change of all the transducers combinations in test at BAM calculated by step-wise and accumulate CWI.

CC and dV/V of all the transducer combinations calculated by all the different CWI methods are presented in Figure 15 (standard CWI), Figure 16 (auto reference CWI), and Figure 17 (Step-wise CWI). Reference signals of all transducer combinations were recorded at the initial state of the beam before the start of the loading procedure. CC and dV/V were then calculated by normal CWI procedure. For the auto reference CWI, when the absolute value of dV/V exceed 1%, the damage in the structure

reached a certain level. It is difficult to compare the following signals with the original reference signal. Thus, the current signal was chosen as a new reference signal until dV/V reached 1% again.

Unusual behaviors of transducer 04 were detected. The CC and dV/V of all the transducer combinations related to transducer 04 varied too much compared to other combinations which were located in the symmetrical positions of the beam. Signals recorded by S02E04 and S03E04 before the start of load test showed that the performance of transducer 04 was not so stable. However, the CC and dV/V related to transducer number 4 calculated by step-wise CWI are still helpful. Before the first cracks appeared, all the transducer combinations successfully detected the different loading steps, especially by step-wise CWI method. The CC and dV/V of transducer combination S02E05 lost their linearity (Figures 15 and 16) at around 37 kN which indicates one or more very early stage crack(s) opening. This change was also detected by almost all the transducer combinations by step-wise CWI method (Figure 17), while by standard and auto reference methods, transducer

combination S01E02 detected this change at 39 kN, as the crack is not in between its direct path area. The combinations of transducers S01E03 and S05E06 were located in the left and right corner on the top of the beam where there was no crack occurrence during the whole experiment. Nevertheless, they still detected the first crack(s) opening at 39 kN. This is very close to the moment when the first cracks started to form. Transducer combination S03E04 detected the first cracks at 38 kN. When the dV/V of transducer combination S03E04 reached -1% at 44 kN, a new reference was chosen automatically; furthermore, the continuous load was detected again. At 66 kN, CC measured by transducer combination S01E03 decreased rapidly. Using the step-wise CWI method, a significant change was detected at 47 kN (Figure 17) by all the combinations between transducer 02, 03, 04 and 05 which were located in the main stress change part of the beam; this indicated a higher level of damage in the beam. A second significant change was detected at 50 kN by all the transducer combinations related to transducer 02, which means the damage was close to transducer 02. According to the accumulated CWI, CC, and dV/V of transducer combinations S01E03 and S02E05 varied the least as they were not located in the damage area.
